RECVLVER COUNTRY PARK GEOLOGY

RESOURCE PACK

Coastal Protection & Geological Background

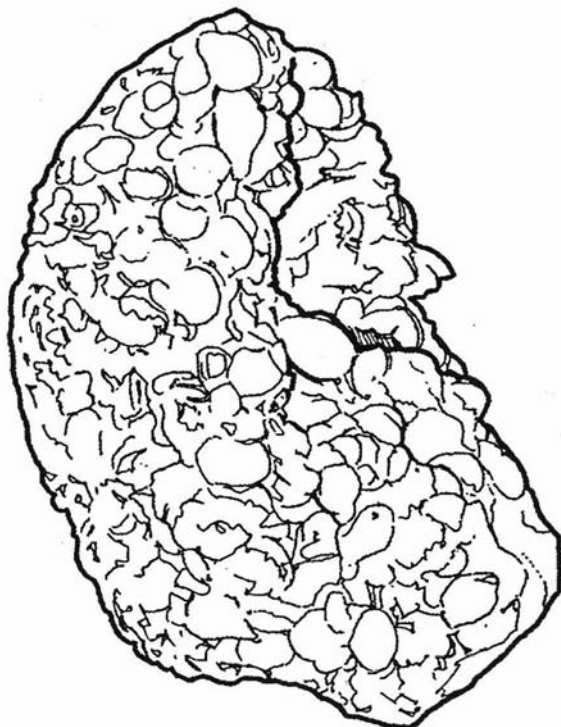
bivalves in a sandstone block
Bothrocorbula regubiensis

As the fossils are continually being washed out of the rock beds the best place to look for them is on the beach at low tide. Fossil shells of bivalves are often found embedded in lumps of sandy rock and fossilised burrows of marine creatures can be seen in large boulders on the beach. Tiny shark's teeth are present in large numbers out on the foreshore near to Bishopstone Glen.

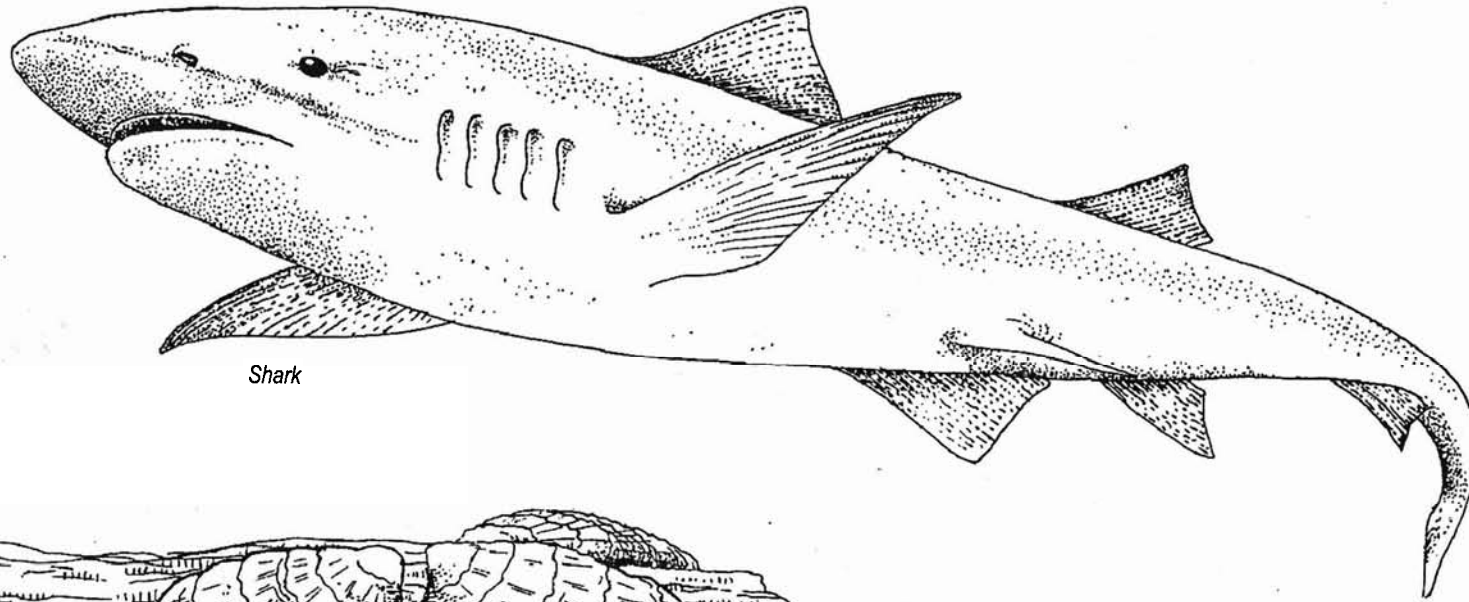
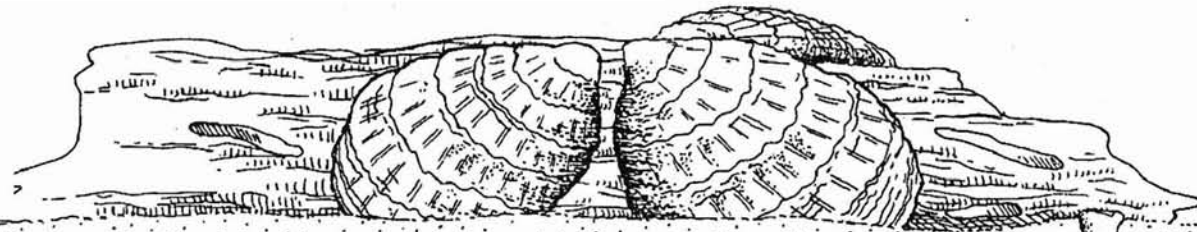
A possible reconstruction for the local Thanet Formation

Shark

Ostrea bellovacina on wood

Dosiniopsis bellovacina

Arctica morrisi

Bothrocorbula regulbiensis

Euspira bassae

The fossils shown in the drawings on page 5, are all found in the area between Reculver and Bishopstone Glen. By careful collecting paleontologists have been able to build up a picture of how each animal, now represented by a fossil, related to each other. A possible reconstruction is shown for the Local Thanet Formation on page 8.

Most of the bivalves were suspension feeders living at various depths in the sediment. *Artica morrissi* lived very near the surface. The snail *Euspira* was carnivorous and probably fed on the bivalves by drilling holes through their shells, much as the modern necklace shells (*Natica*) do. Other burrowing marine creatures were also abundant.

Occasionally fossil wood is found which would have drifted in from adjacent land areas. When this became waterlogged and sank it sometimes provided attachment sites for the oyster *Ostrea bellovacina* particularly where conditions were less saline (estuarine). The shark *Striatolamia striata* would have been hunting in the waters above.

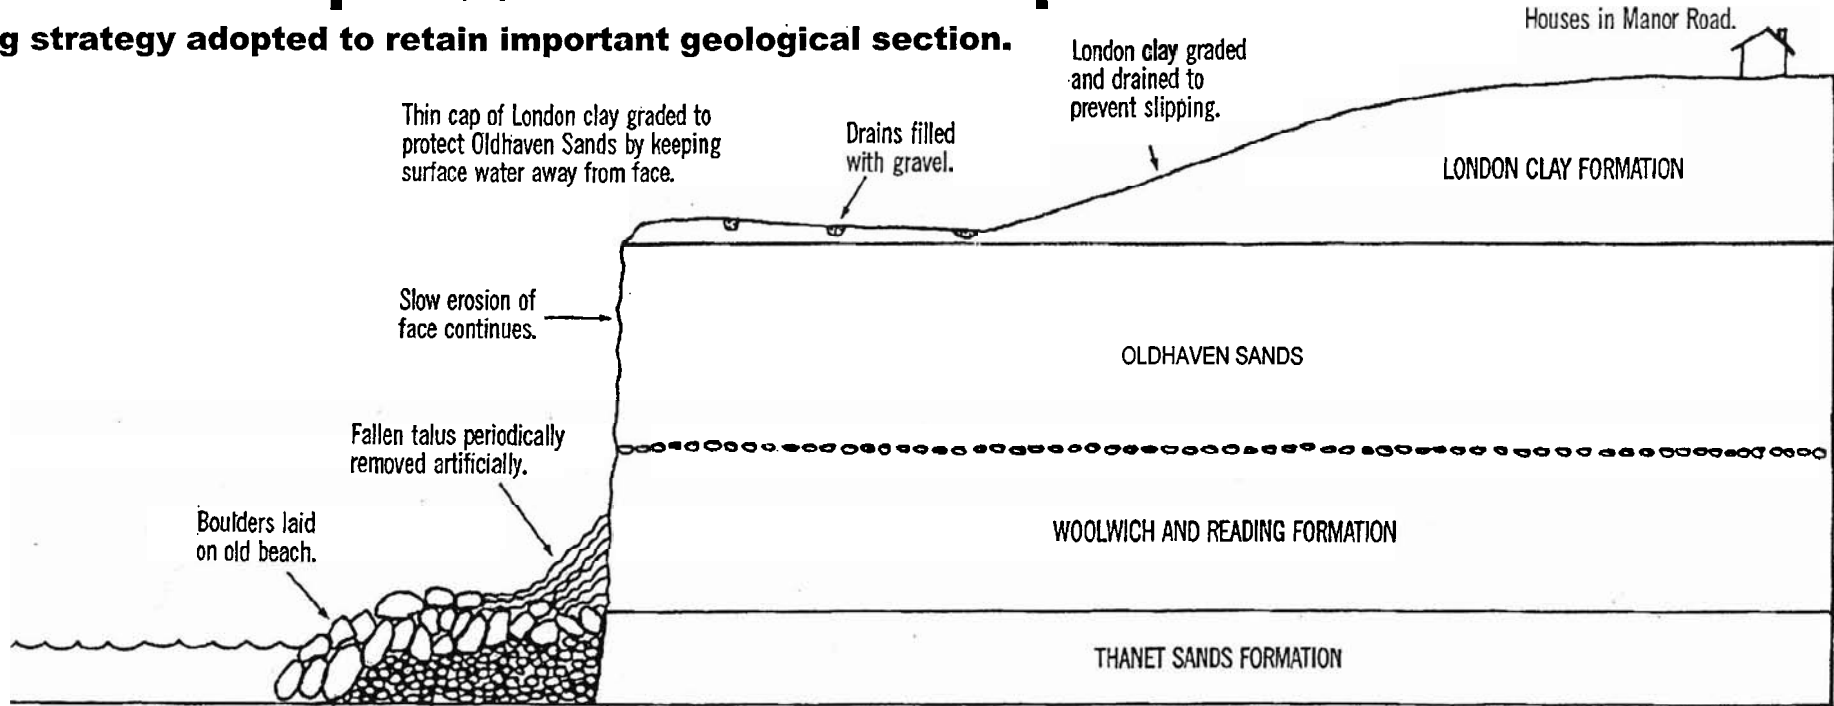
Recent coastal protection east of Bishopstone Glen

Showing strategy adopted to retain important geological section.

By contrast Canterbury City Council, with advice from the Nature Conservancy Council, has recently carried out a much more imaginative scheme to the east of Bishopstone Glen. This novel approach has set a precedent for coastal protection at similar important geological sites around Britain's coasts. See page 10.

This scheme slows erosion to an acceptable rate rather than halting it completely. Rapid erosion occurs at the cliff base so this has been protected by large boulders which absorb the sea's energy (the rock used comes from Scandinavia and is known as hornblende gneiss) At the cliff top the London Clay has been graded and drained to prevent slippage damage to the properties in Manor Road. However, a thin clay cap has been retained. This is to protect the underlying sands from the erosive effects of excessive surface water.

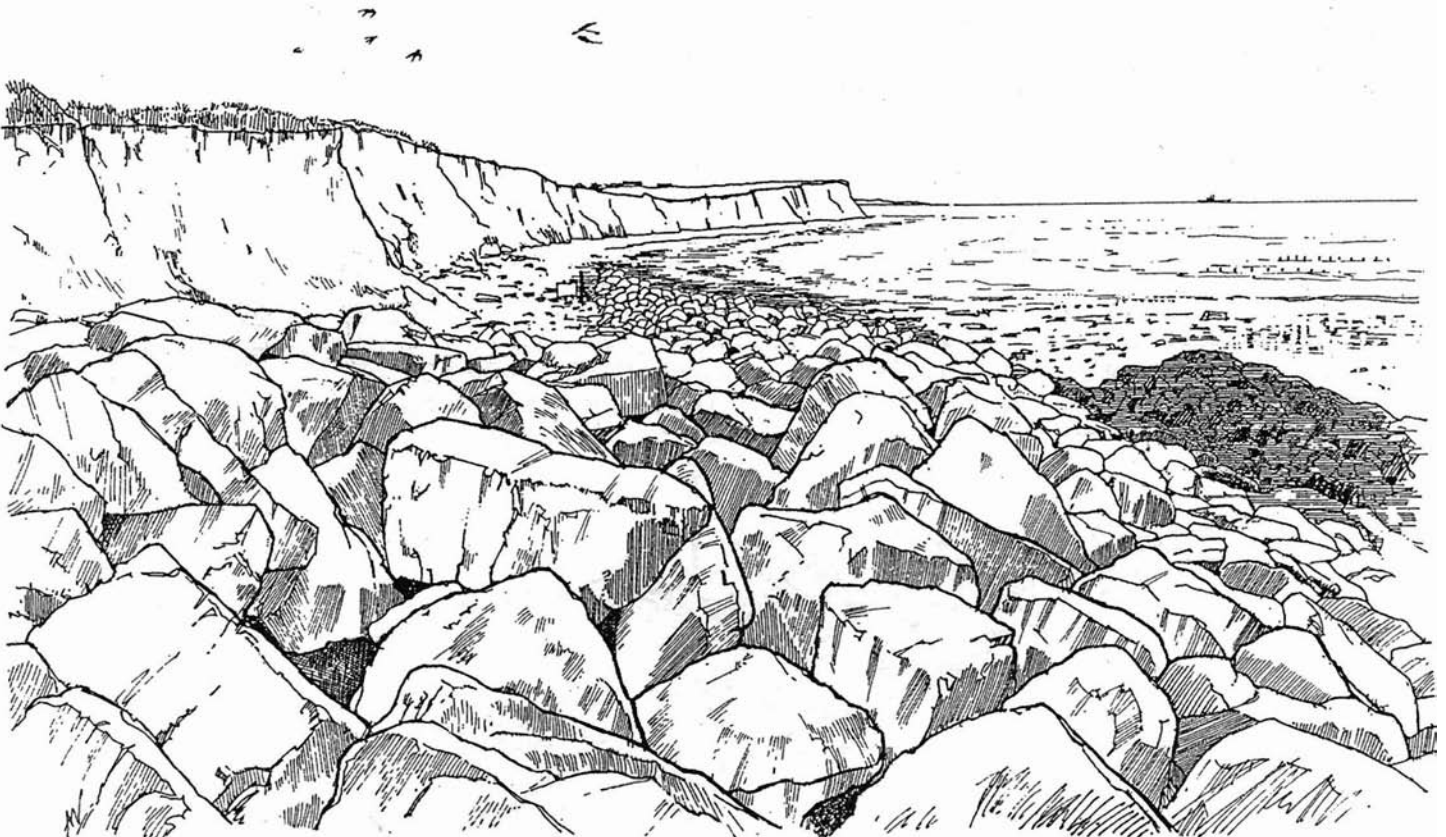
The use of the silicon chip in computers brought a new dimension to the field of coastal engineering. For the first time scientists could recreate wave patterns in the laboratory which exactly matched those found in nature. This in turn meant that they no longer had to wait for a storm to see how a sea wall would behave. Now they could subject models of proposed sea defences to any storm intensity they wanted and do it over and over again to check their results. These experiments showed that a wall which was properly curved in cross section offered more protection than a vertical wall of the same height simply because the curved shape threw the waves back out so to sea.

Work done in the United Kingdom produced a new shape which was thought to be the most cost-efficient general design for a sea wall. A front curved wave wall deals with ordinary tides while the higher wall set at the back of an access way deals with the more serious storms. The length of sea wall just to the Herne Bay side of Bishopstone Glen is based on this work.
